HYDRAULIC MODEL STUDIES ON THE SPILLWAY
AND STILLING-BASIN FOR THE ALAMOGORDO
DAM--CARLSBAD PROJECT, NEW MEXICO

Hydraulic Laboratory Report No. Hyd.-243

MAY 25, 1948

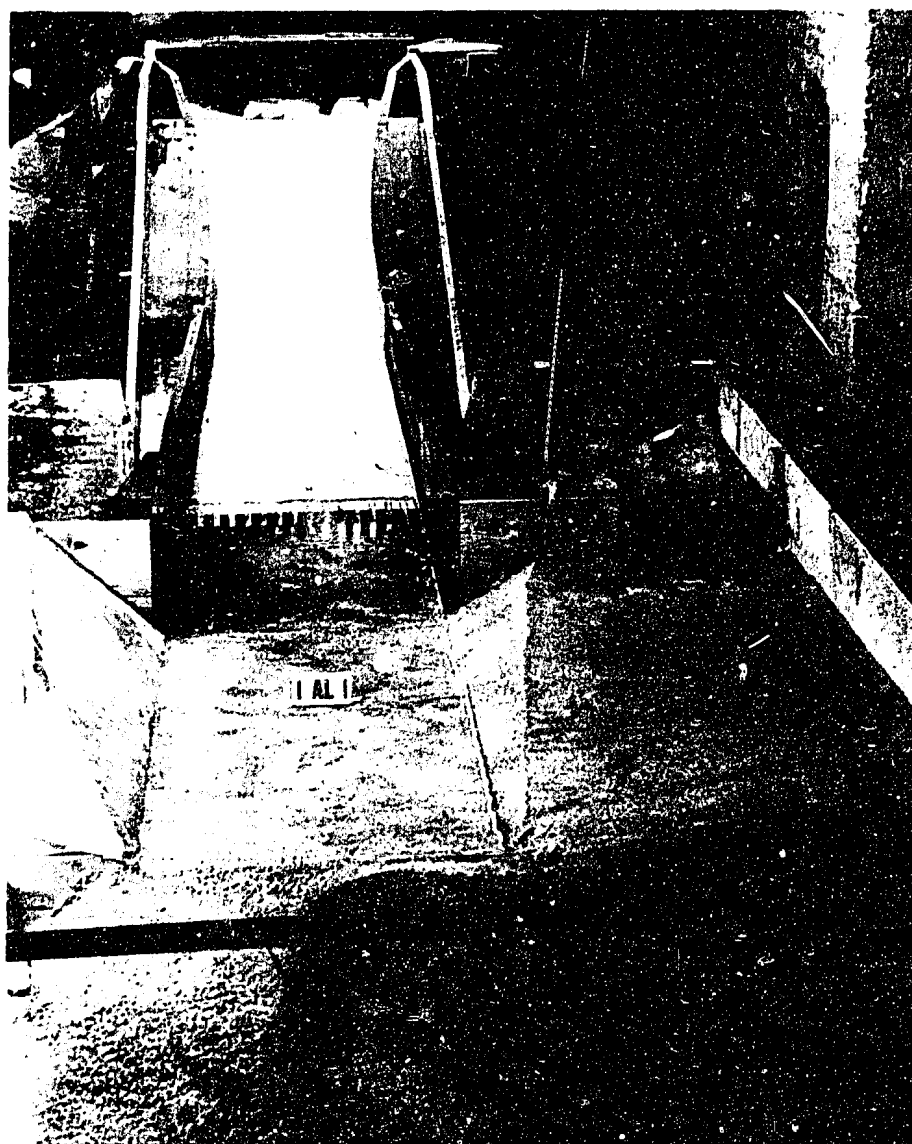
Figure 9

Original Design - Test 1.

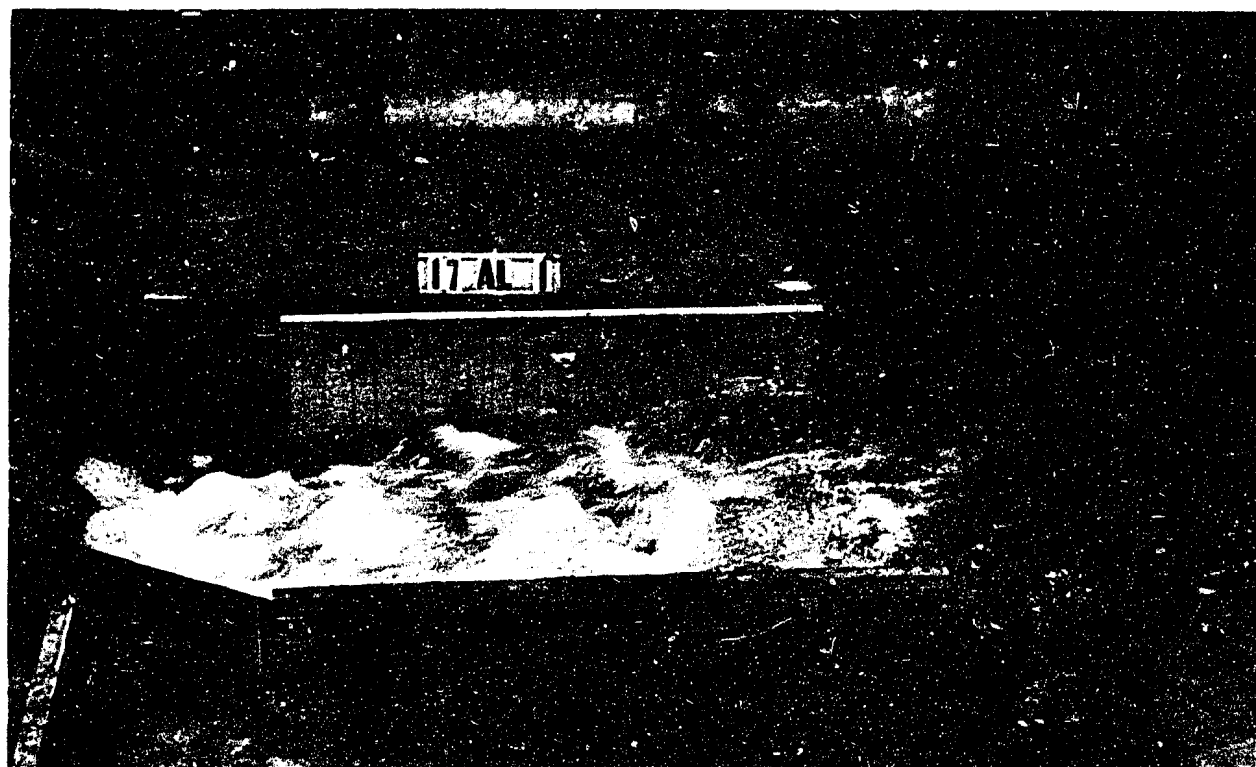
A. River channel before operating.

B. Discharge 28,000 second-feet. Tailwater 4157.2 feet.

TEST 22 - ALAMOGORDO DAM, 1:64 MODEL

In the final tests, sheet metal was again used to represent the right riverbank as shown in Figure 13A. The jump location and stilling-pool action were satisfactory. Figure 13B shows operation at 28,000 second-feet with corresponding tailwater elevation 4157.2 feet. After one and one-fourth hours of operation at this discharge the photograph, Figure 14A, was taken. Resulting erosion was slight. Scour showed some increase after 1 hour operating at 56,000 second-feet, Figure 14B, but was still satisfactory.

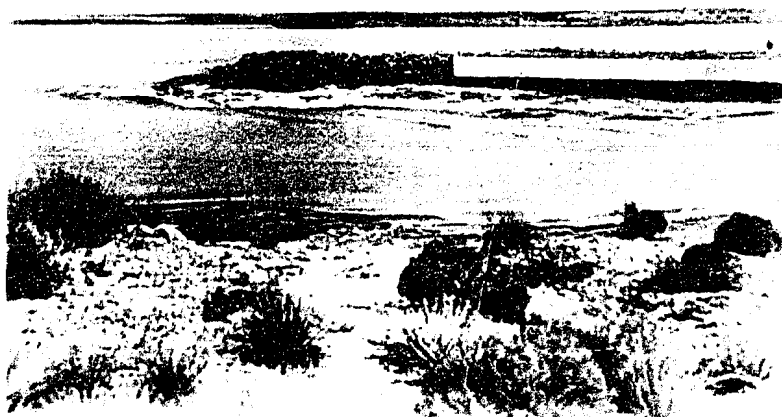
A. Model discharge of 56,000 second-feet.

B. Prototype of discharge of 42,000 second-feet.

ALAMOGORDO DAM. MODEL-PROTOTYPE
COMPARISON OF FLOW ENTERING SPILLWAY

Two photographs of the prototype operation are presented in this report together with the corresponding model photographs. Flow entering the model spillway is shown in Figure 19A with the prototype action shown in Figure 19B. Very close similarity is shown in the rough water surface caused by the interference of the spoil bank on the left side of the entrance channel. Figure 20 shows model and prototype flow in the spillway chute. The similarity of performance is again evident. The three fins are present, but their magnitude in the prototype is greater than indicated by the model, probably due to insufflation of air at the higher velocities in the prototype.
